ILMT Project Status: After November 2016

- Progress since November 2016
- Future plans

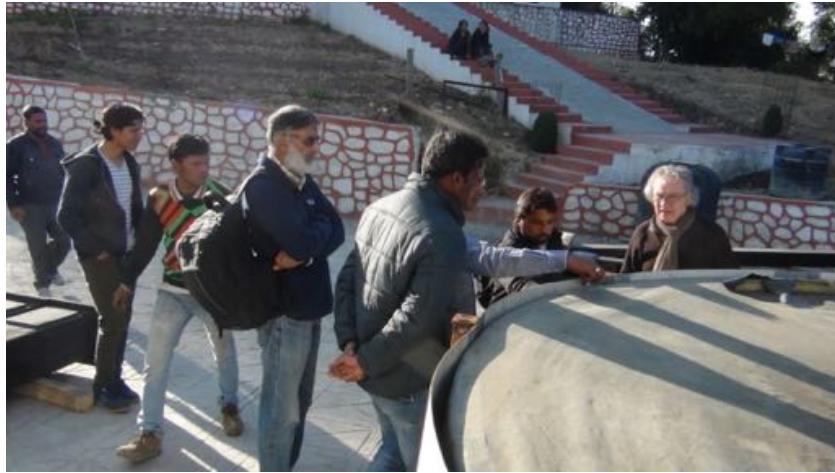
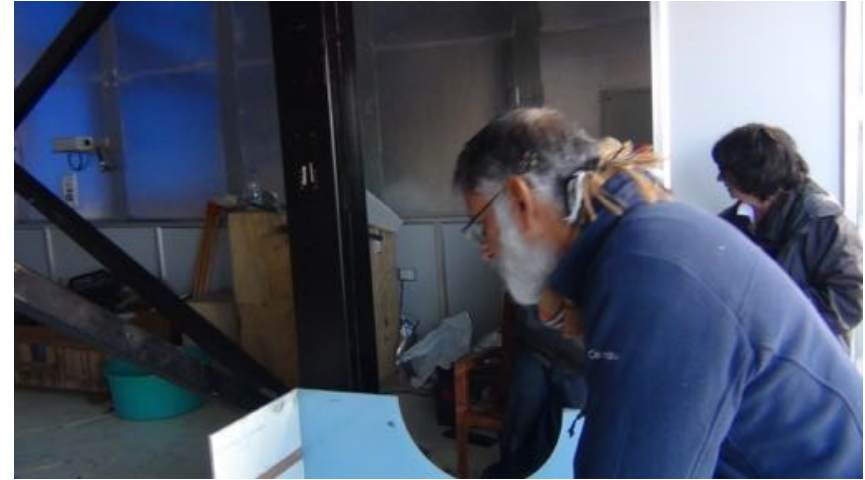
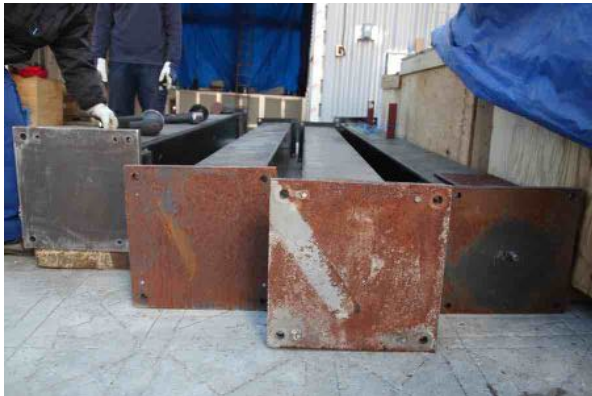
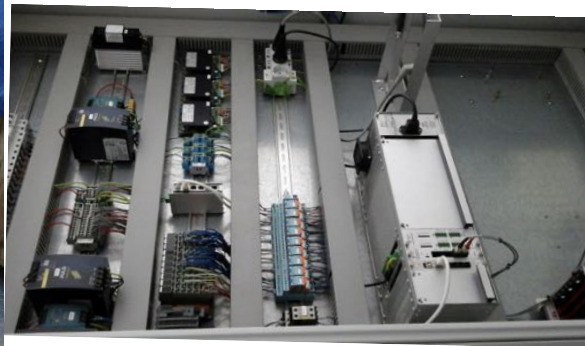
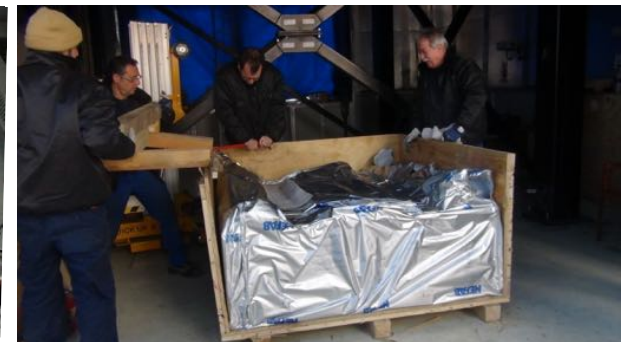
Mechanical structure: Joint inspection of stored ILMT equipments

A joint committee inspection team, inspected the stored equipment and mirror. No major damage seen though there was rusting, etc, plus some cracks on mirror edges.

- **Immediate next (October 2017):** Mirror crack repair being done.
- For different orientations of the air bearing w.r.t the mirror container, the “vertical run-out” and “tilt stiffness” measurements are being carried out in order to determine the optimal relative orientation
- AMOS mission for mirror control system in **March 2018 is envisaged.** Prof. P. Hickson also plans to be present.
- **First light planned during spring 2018:** final check on the integration of the pneumatic, mirror control and observatory control systems is planned to achieve this key mile stone.

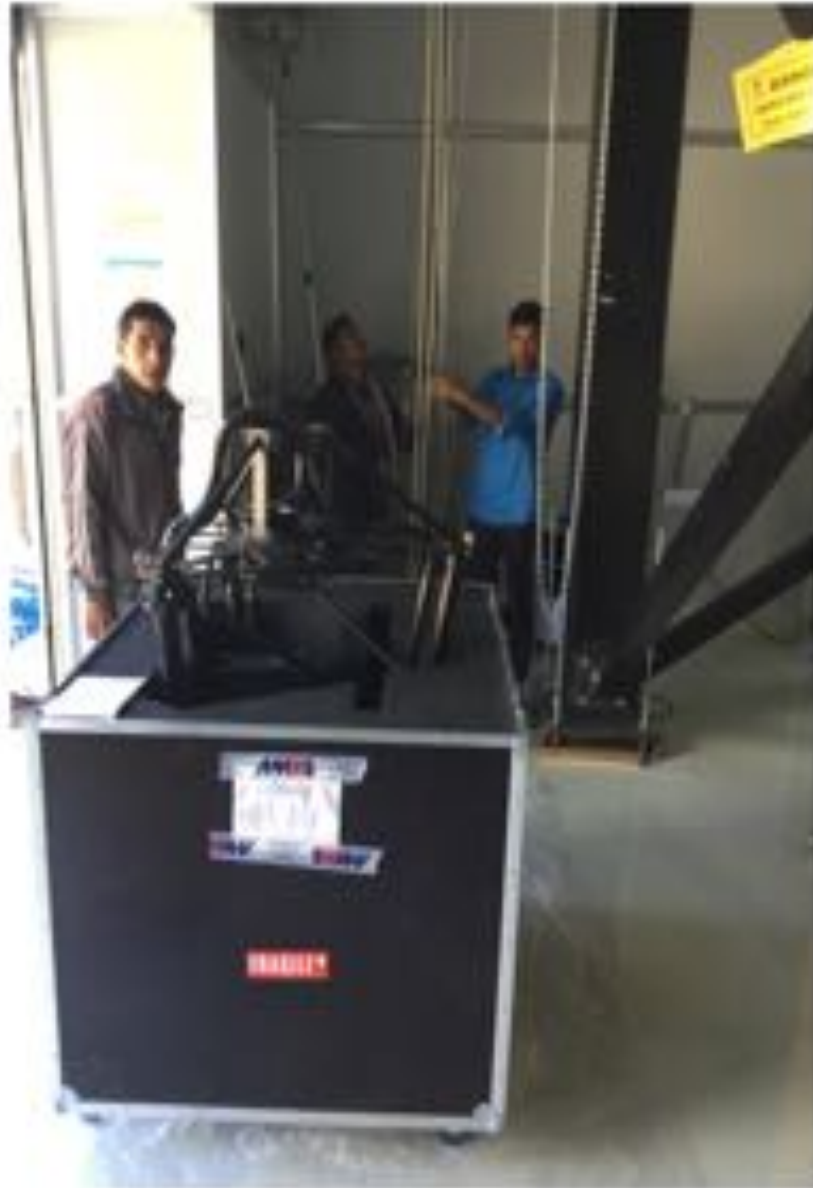
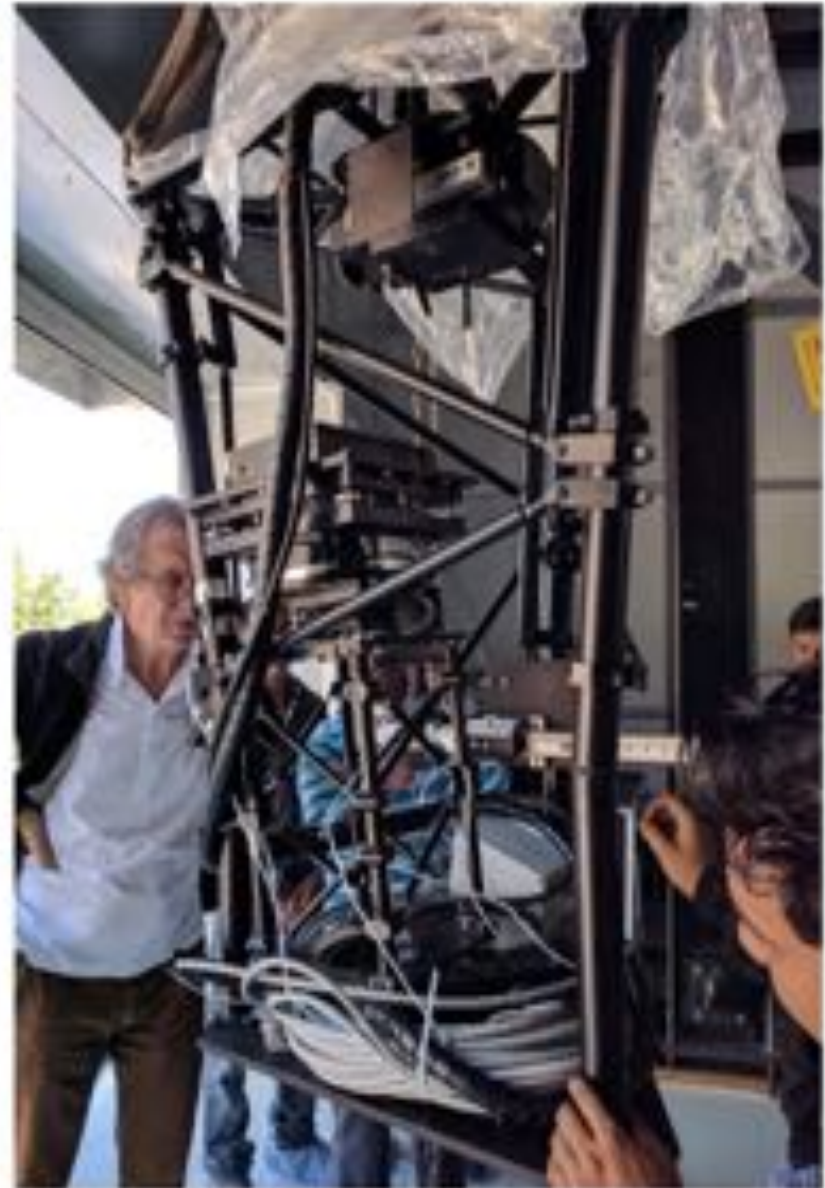
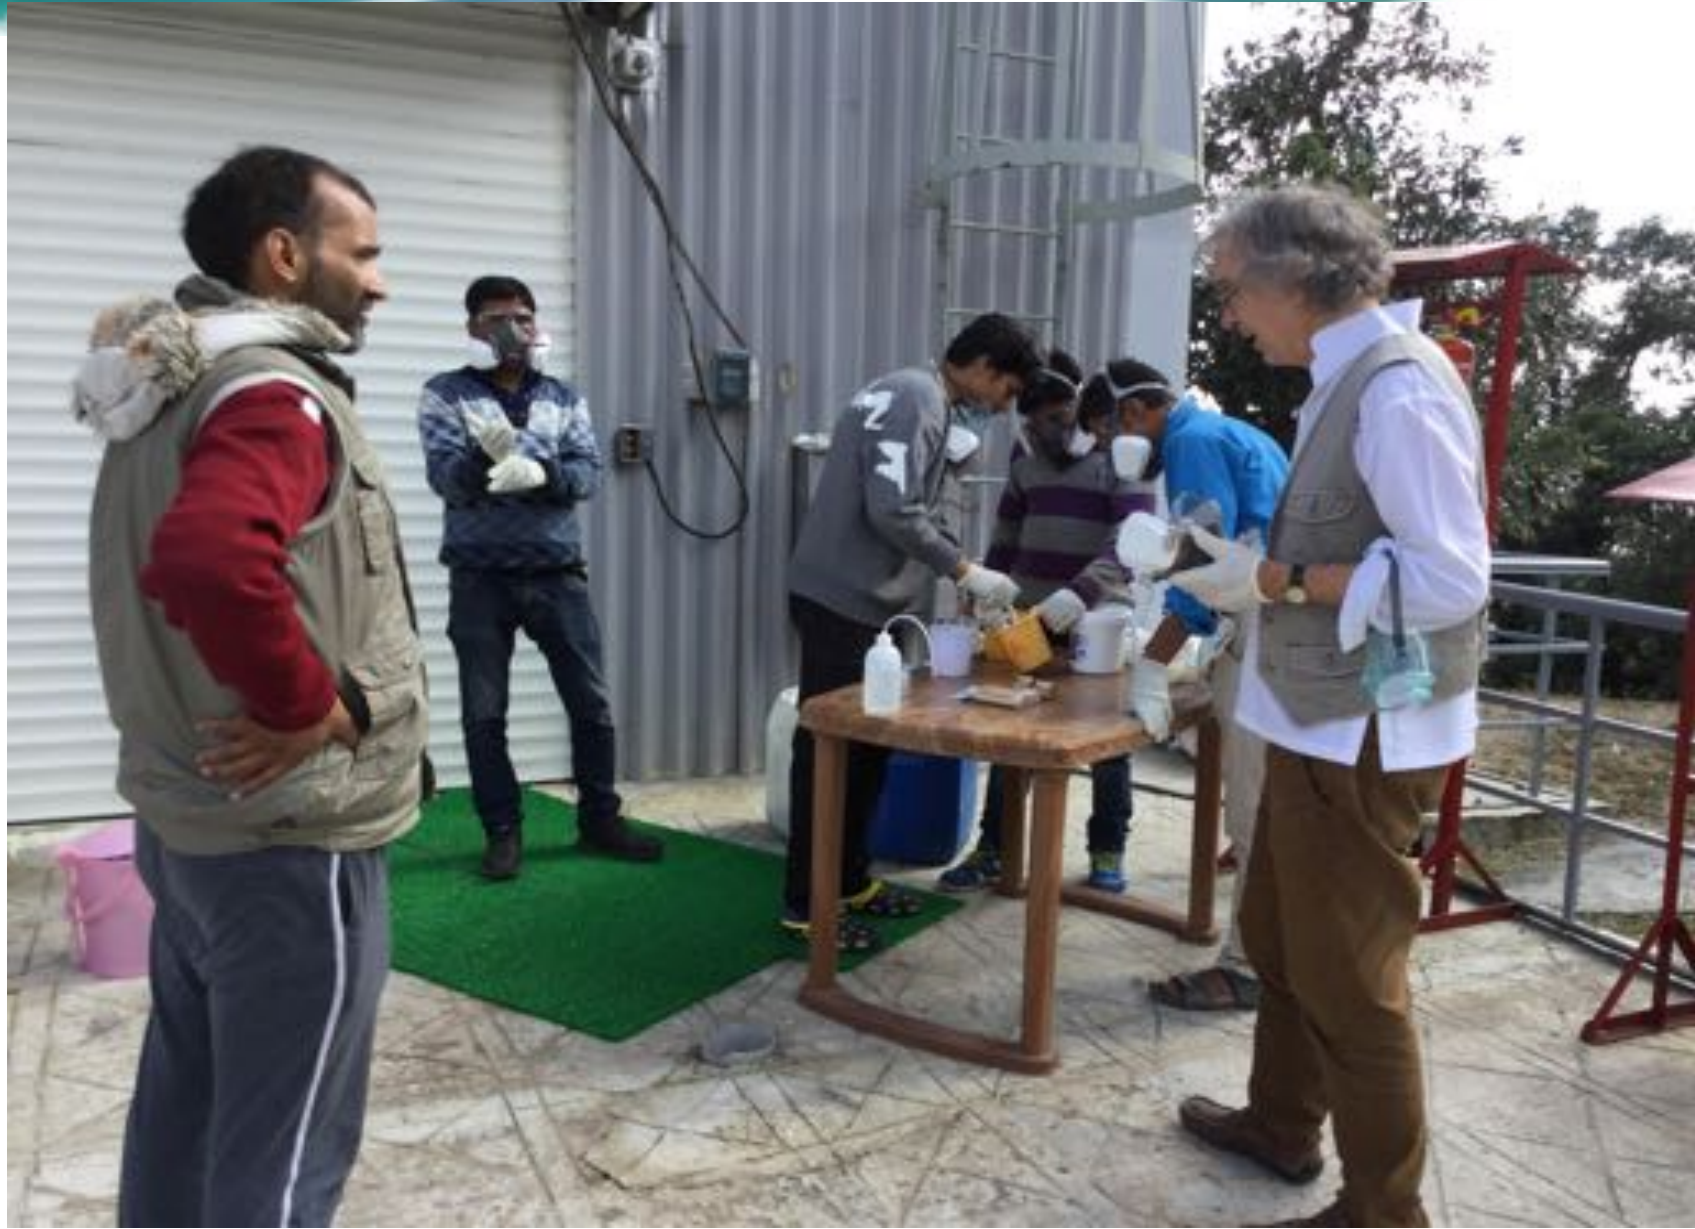
Bad surprise

- **During our present visit (October 2017):** The mechanical interface between the optical corrector and the CCD camera has been unpacked and found to be damaged (discussions are presently taking place between AMOS, the transporter and the insurance provider)
